DRAFT
Specific Site Assessment for
Coal Combustion Waste
Impoundments at Empire
District Electric Company
Asbury Power Station
Asbury, Missouri

January 2011
Project 092884

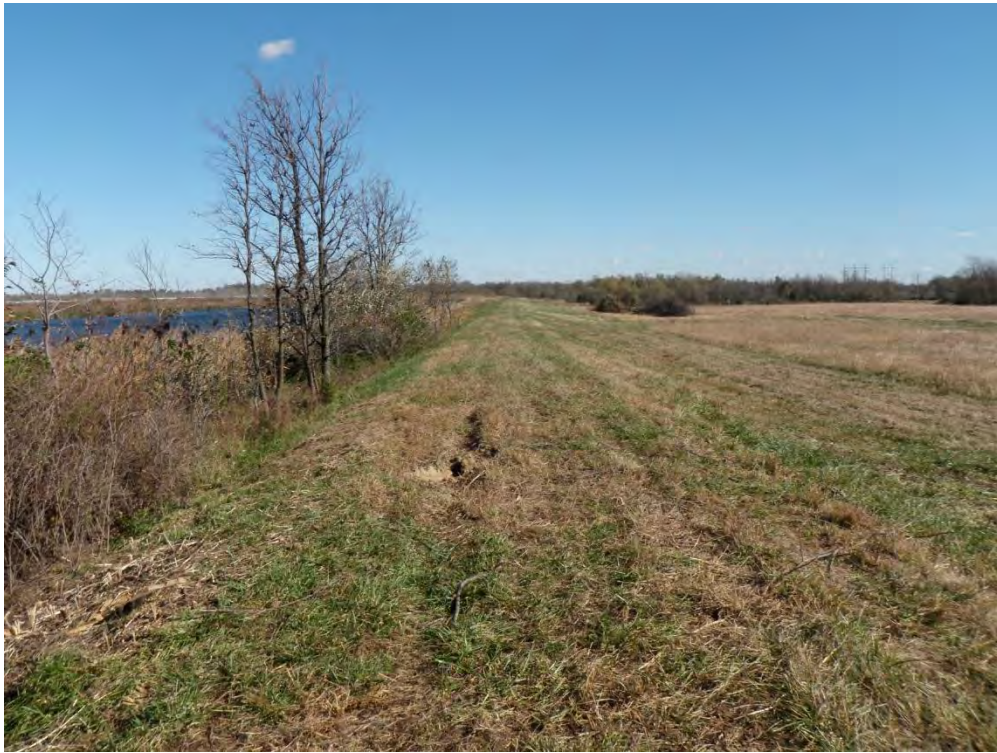
Photo 1: Lower Pond crest and upstream slope at southwest corner of pond looking east.

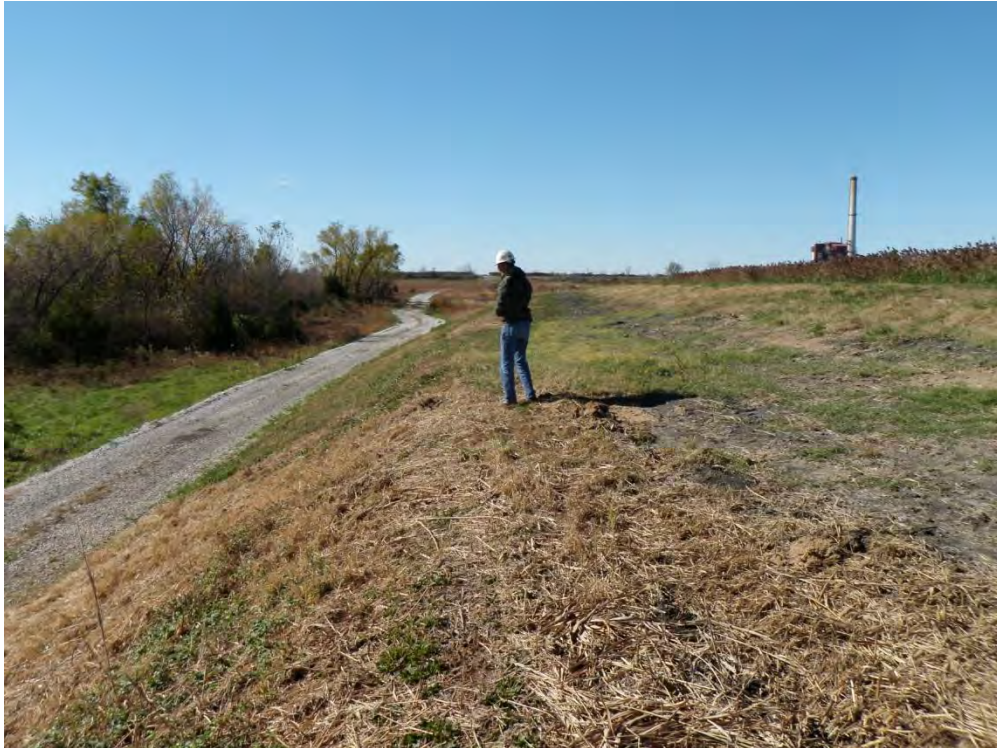
Photo 2: Lower Pond downstream slope at southeast corner of pond looking west.

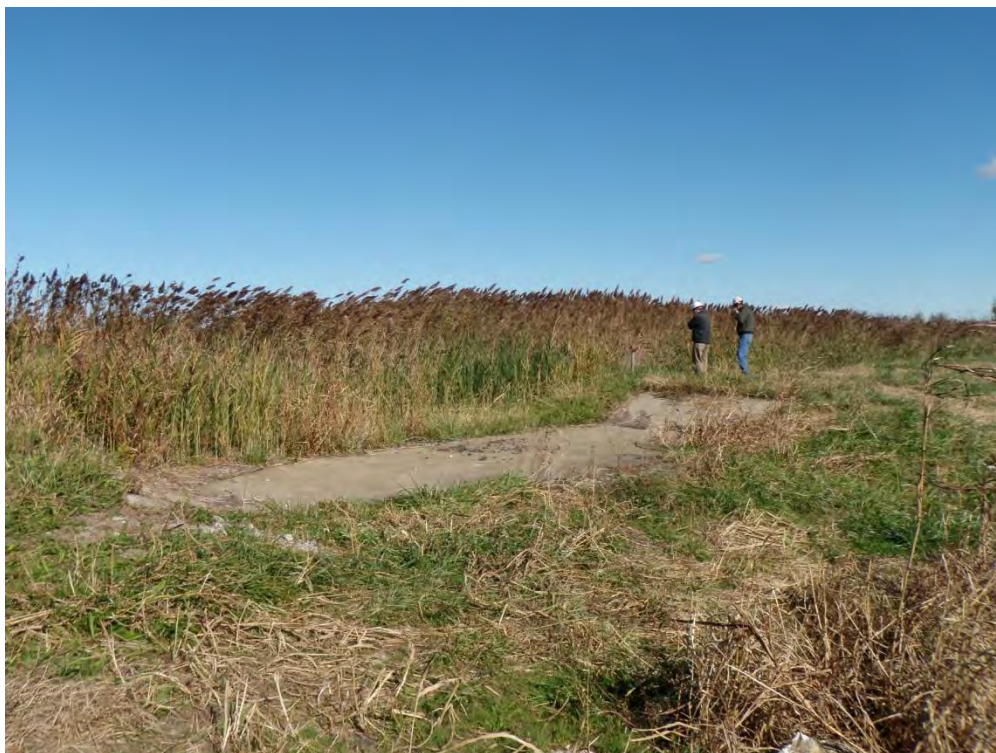
The emergency spillway near the southeast corner of the Lower Pond was covered with vegetation, but the structure appeared to be in generally good condition.

Photo 3: Lower Pond overflow spillway near southeast corner of pond.

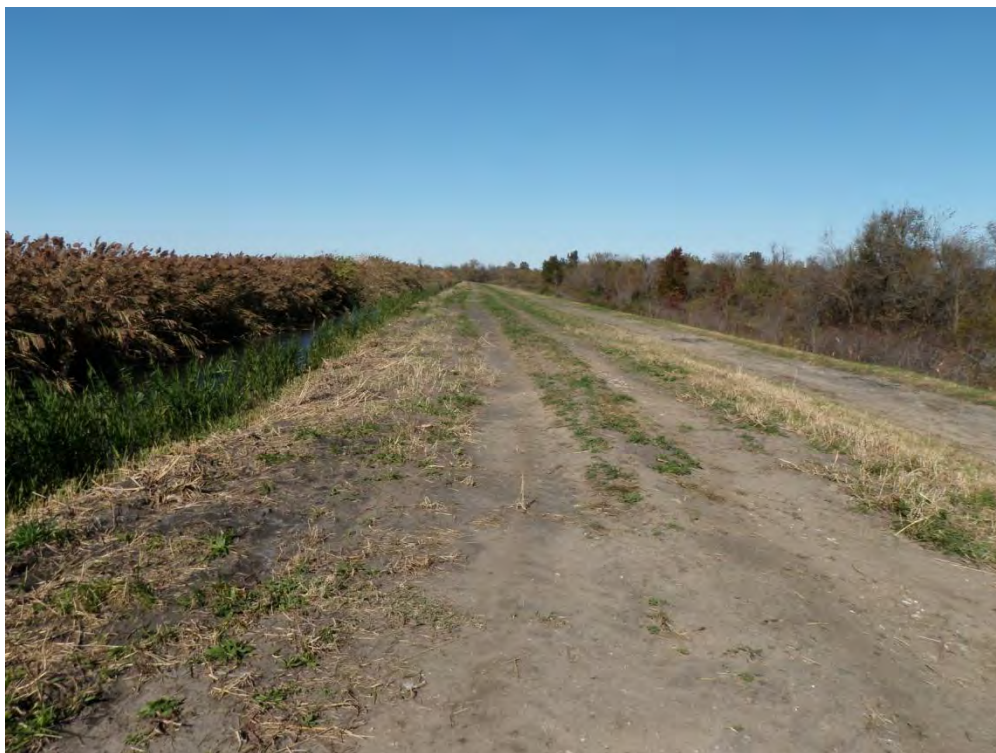
Photo 5: Lower Pond upstream slope and crest at southeast corner looking north.

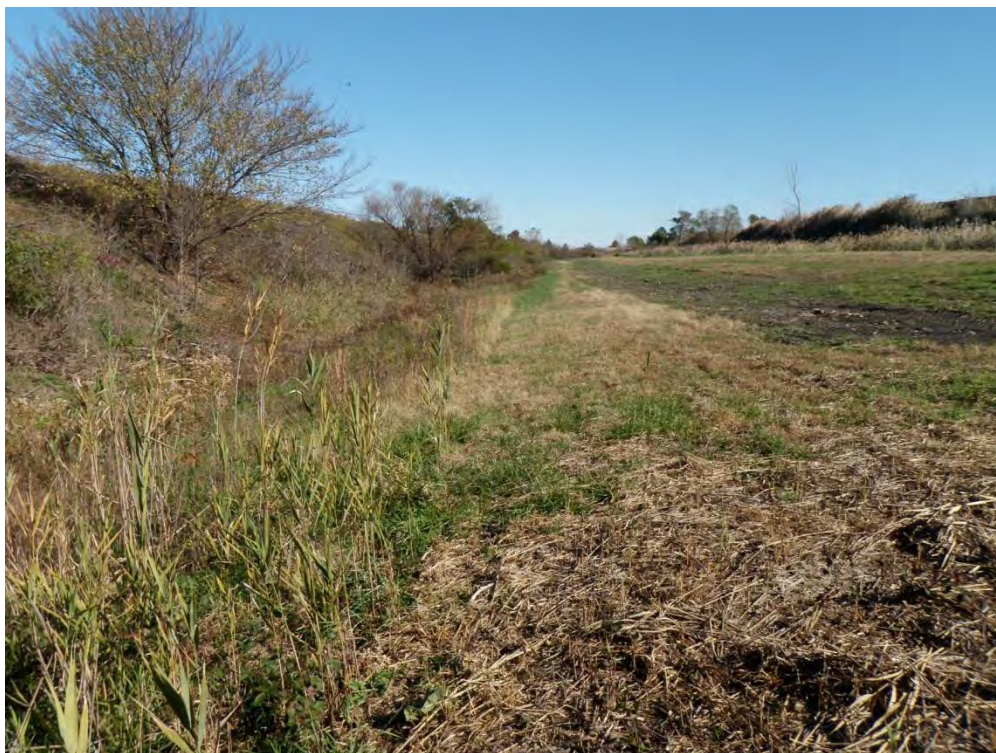
Photo 9: Lower Pond downstream slope at northwest corner of pond looking east.

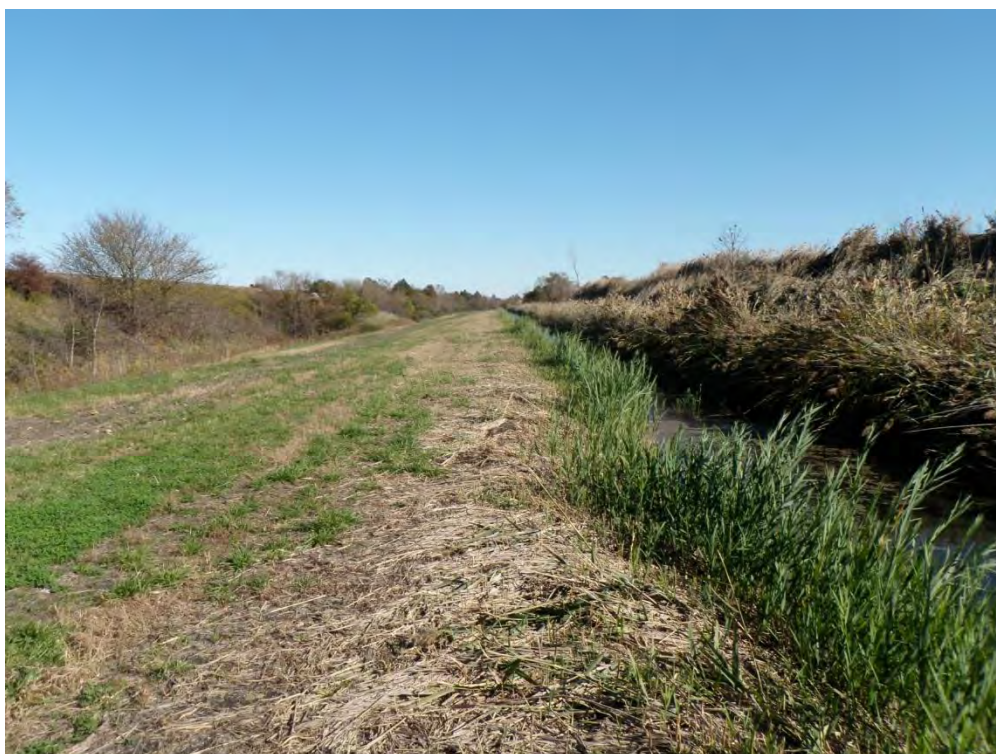
Ash stored in the Lower Pond is stored in large piles approximately 25 feet high along the north and east portions of the storage cell. These storage piles create an inner ash basin which was observed to be higher than the perimeter embankments. This ash could potentially become saturated during storm events and induce higher than anticipated loads on the perimeter embankments, most notably the east embankment.

Photo 10: Lower Pond crest and interior perimeter ditch at northwest corner of pond looking east. Note ash pile built up to the right of the ditch.

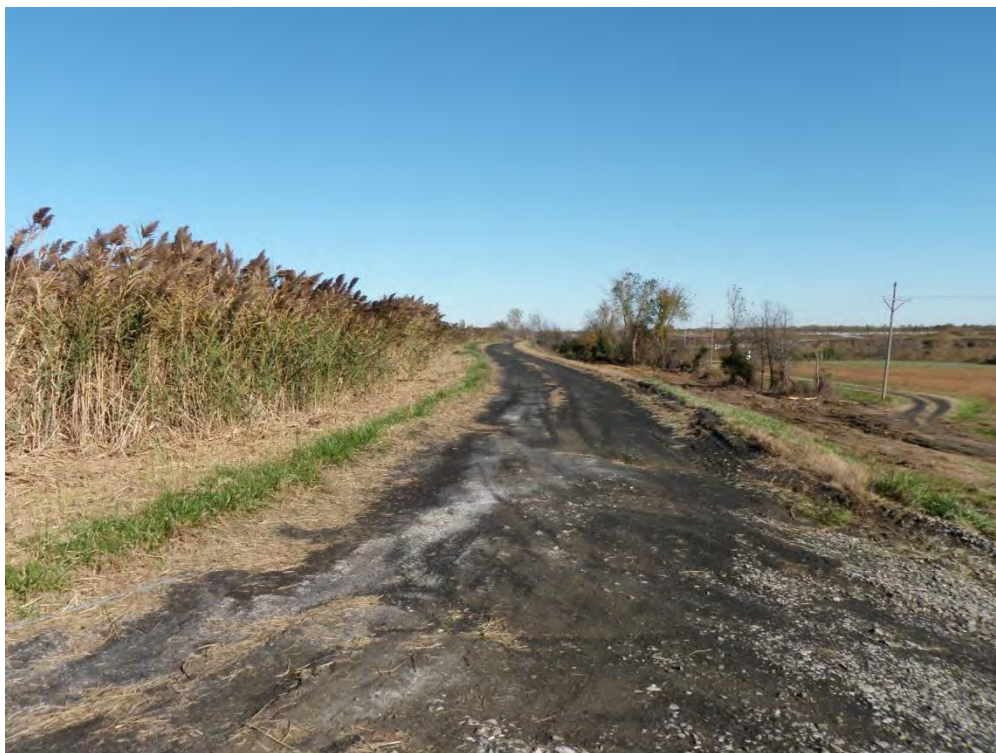
Photo 11: Upper Pond crest and upstream vegetation at southeast corner of pond looking north.

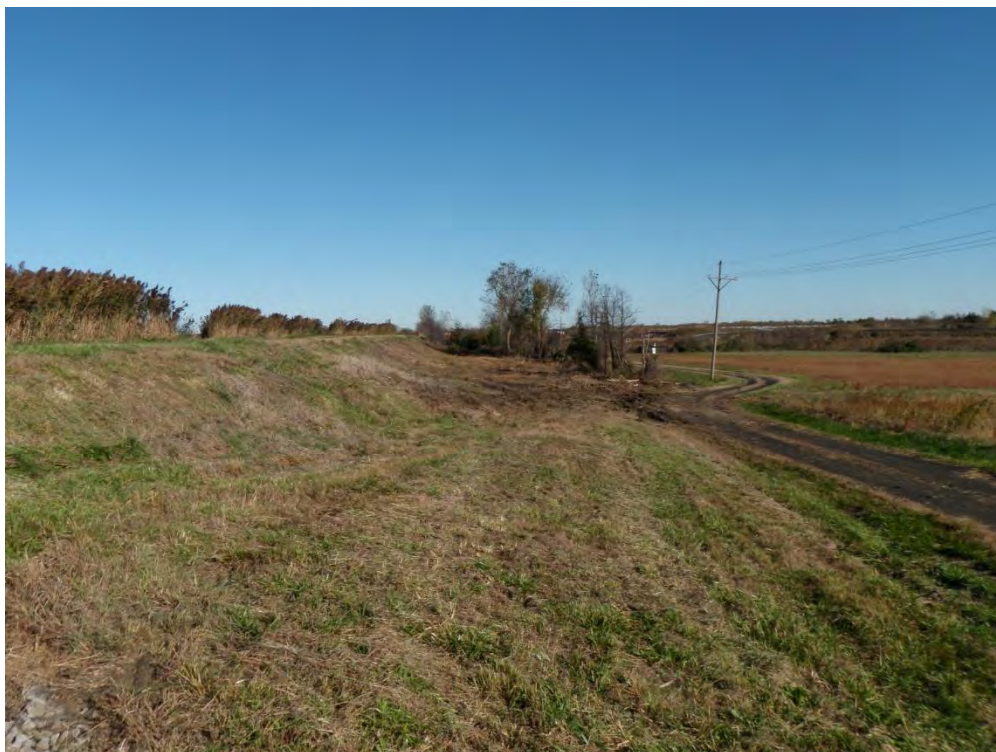
Photo 12: Upper Pond downstream slope and tree growth at southeast corner of pond looking north.

1. Continue and improve vegetation control efforts to maintain the downstream embankment slopes free of heavy vegetation and tree growth. Existing trees should be removed to prevent the root systems from creating seepage paths through the embankment slopes. A minimum of about 25 feet of clear space should be provided between the downstream toe and the tree line. Removal of root balls of large trees can cause additional damage to an embankment and removal is not recommended without appropriate engineering planning and consideration.

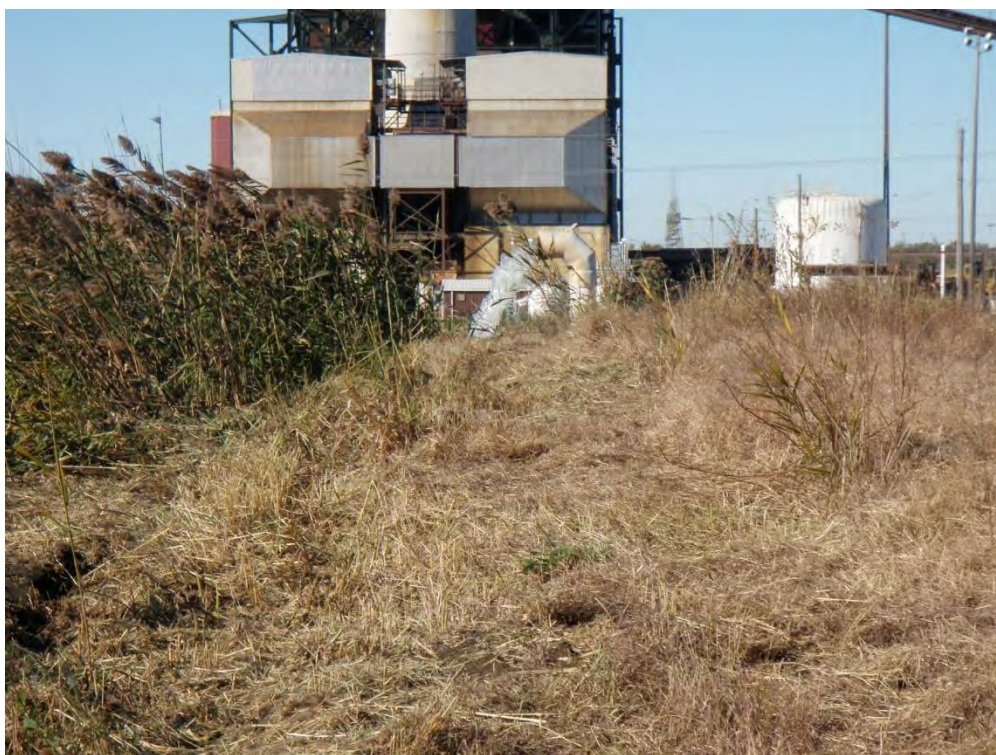
Photo 15: Upper Pond discharge flow from Lower Pond pumphouse.

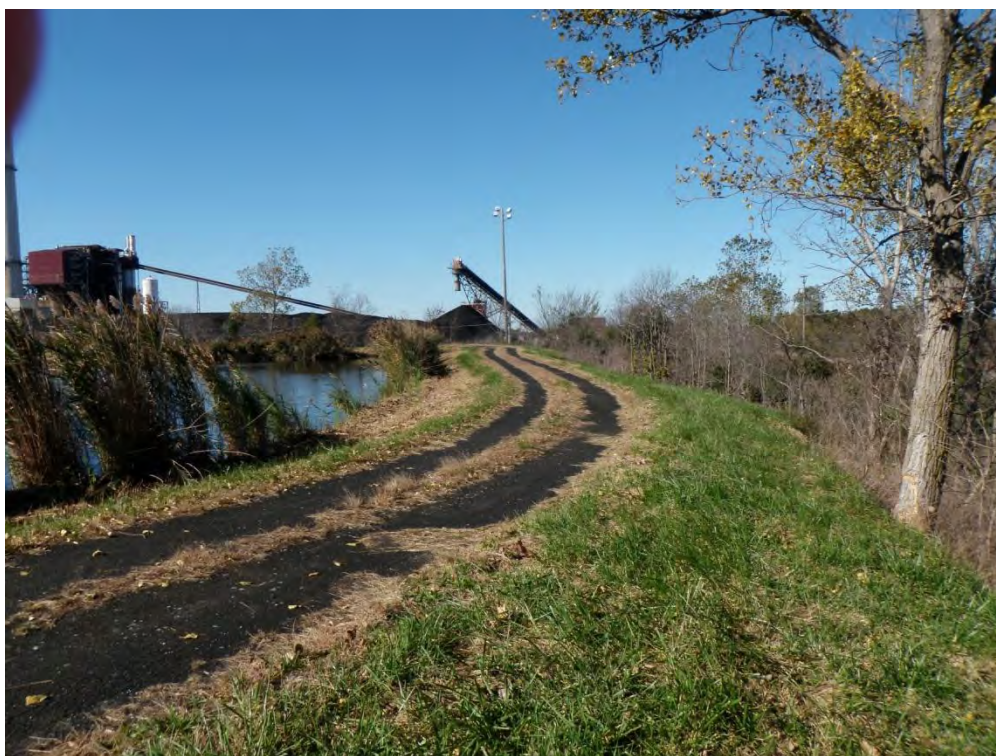
Photo 16: Upper Pond crest and upstream slope at northeast corner of pond looking west.

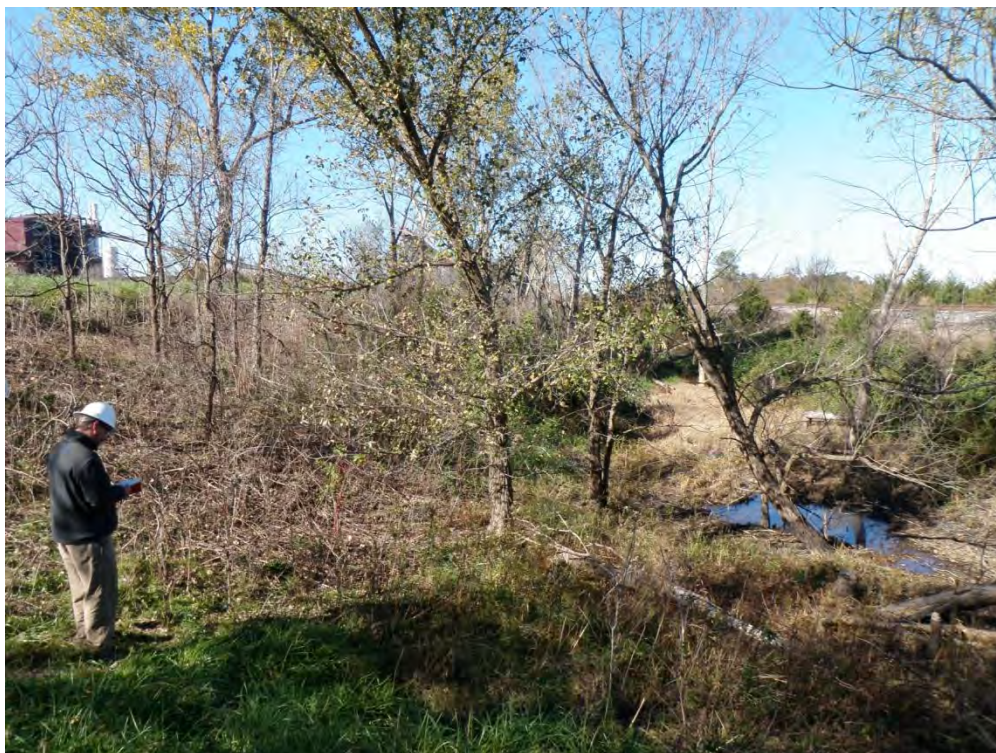
Photo 17: Upper Pond downstream slope at northeast corner looking west.

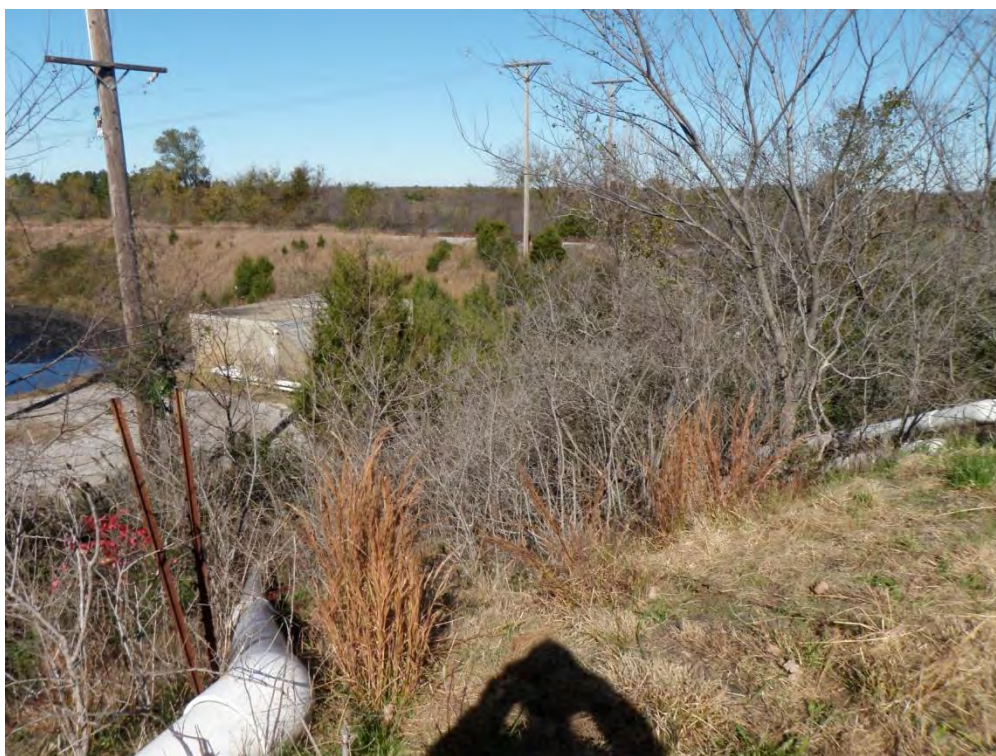
Photo 18: Upper Pond coal pile sump at northwest corner. Note sump discharge pipes aligned into Upper Pond.

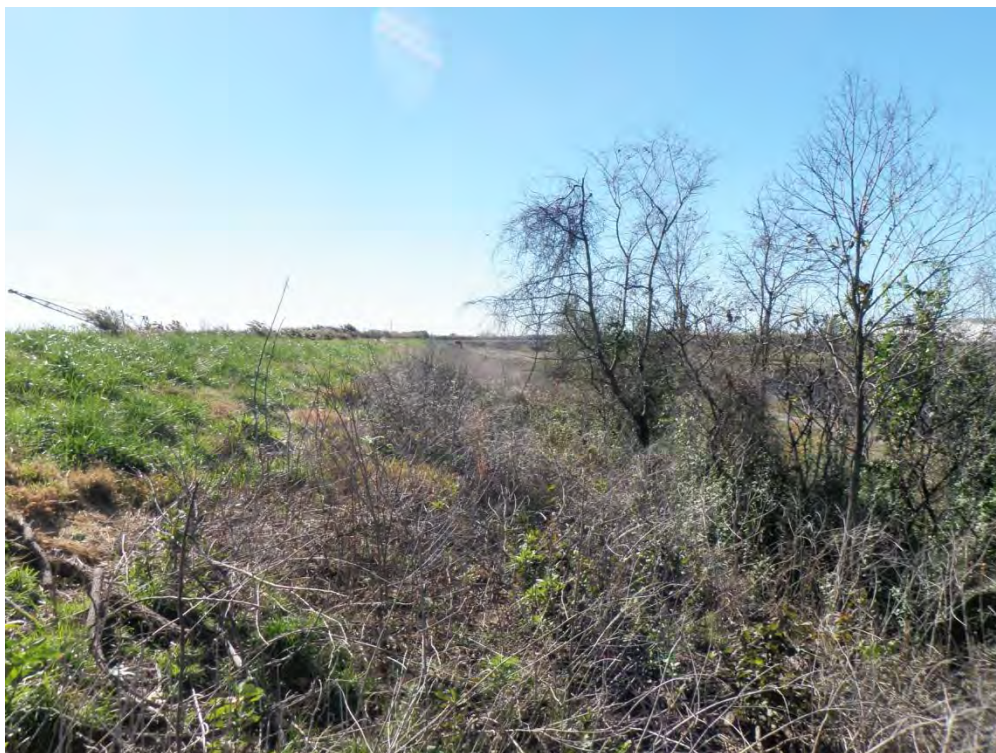
Photo 21: Upper Pond downstream slope at northwest corner looking south.

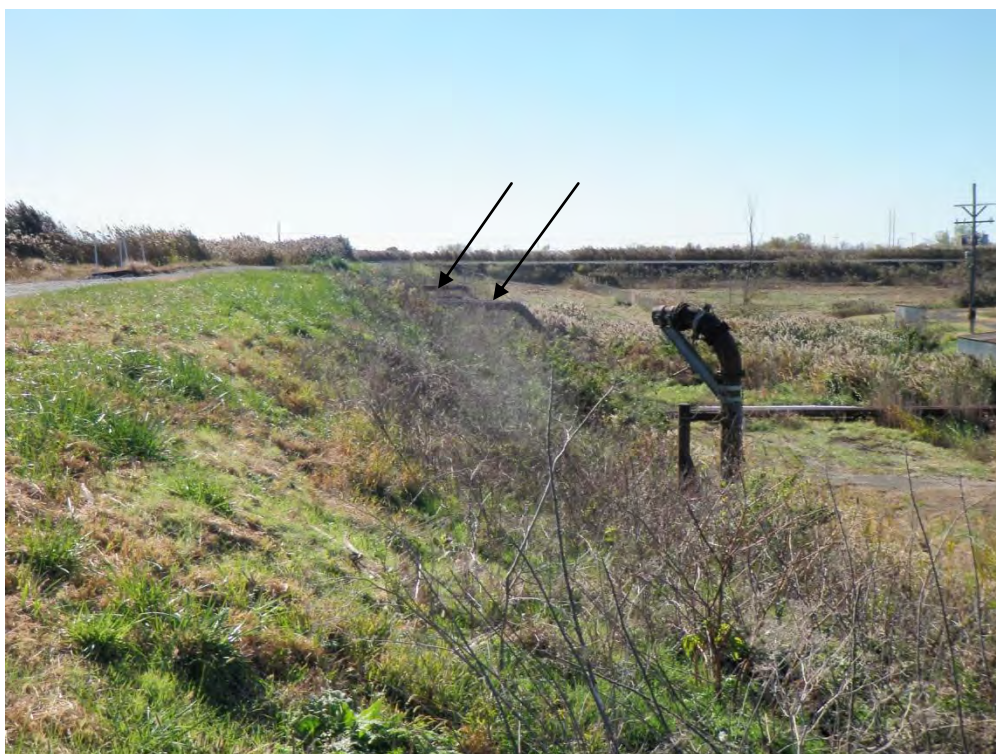
Photo 22: Upper Pond downstream slope where CCW discharge pipes (note arrows) cross through and continue to the Lower Pond.

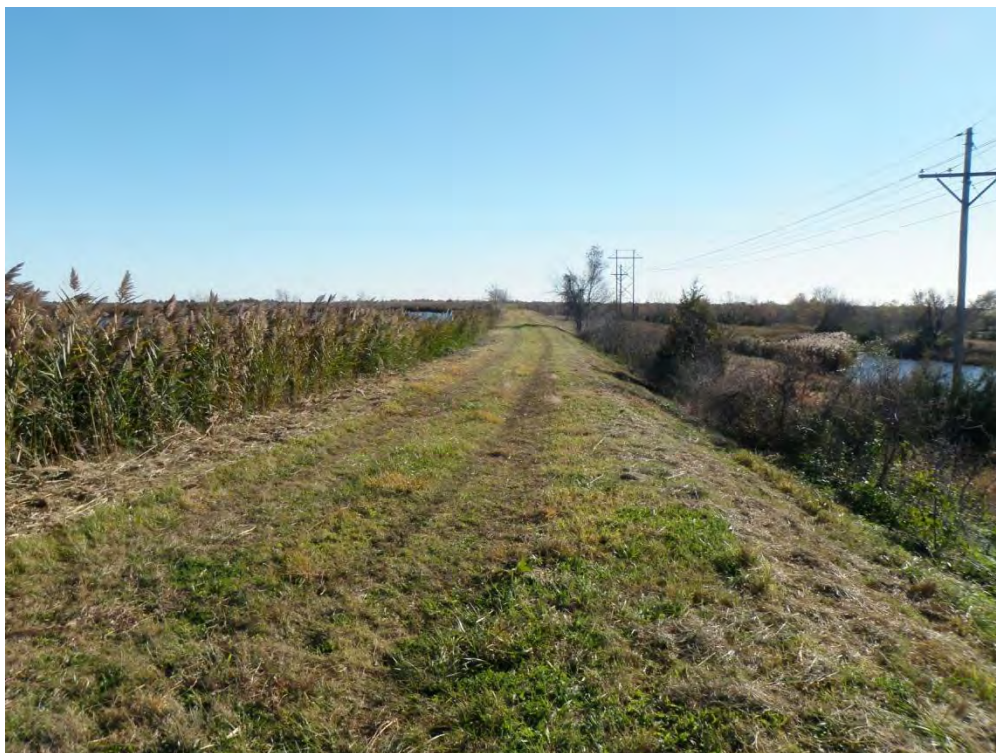
Photo 25: South Pond upstream slope and crest at southwest corner of pond looking east.
